COMMENT TO THE STB BY MICHAEL A. TRUJILLO 1/17/2010
ENTERED
Office of Proceedings

28 West 5th Avenue, Antonito, Colorado

I will speak particularly to the condition of the bridges, the irrigation ditch bridges, the materials used for construction, the culverts, railroad crossings, maintenance and wetlands.

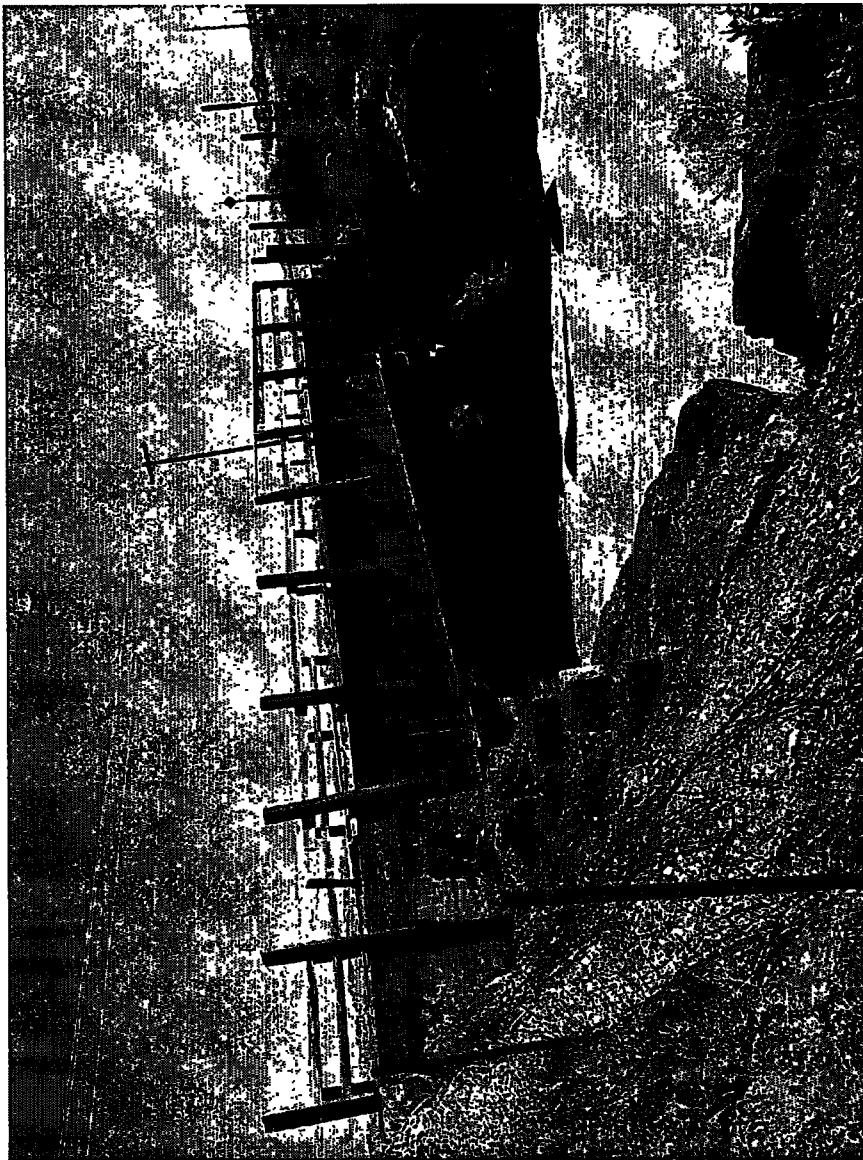
San Antonio Bridge (west perspective) situated North 37 degrees ,03 minutes ,52 seconds, West 160degrees ,00minutes, 25 seconds. Bridge runs North and South and rests at each riverbank on a combination of basalt and bedrock. In some cases, concrete pads have been added to stabilize apparent previous failures of both the basalt and the bedrock. No loading capacity of bridge is noted in any area. Elevation: 7910ft above sea level.

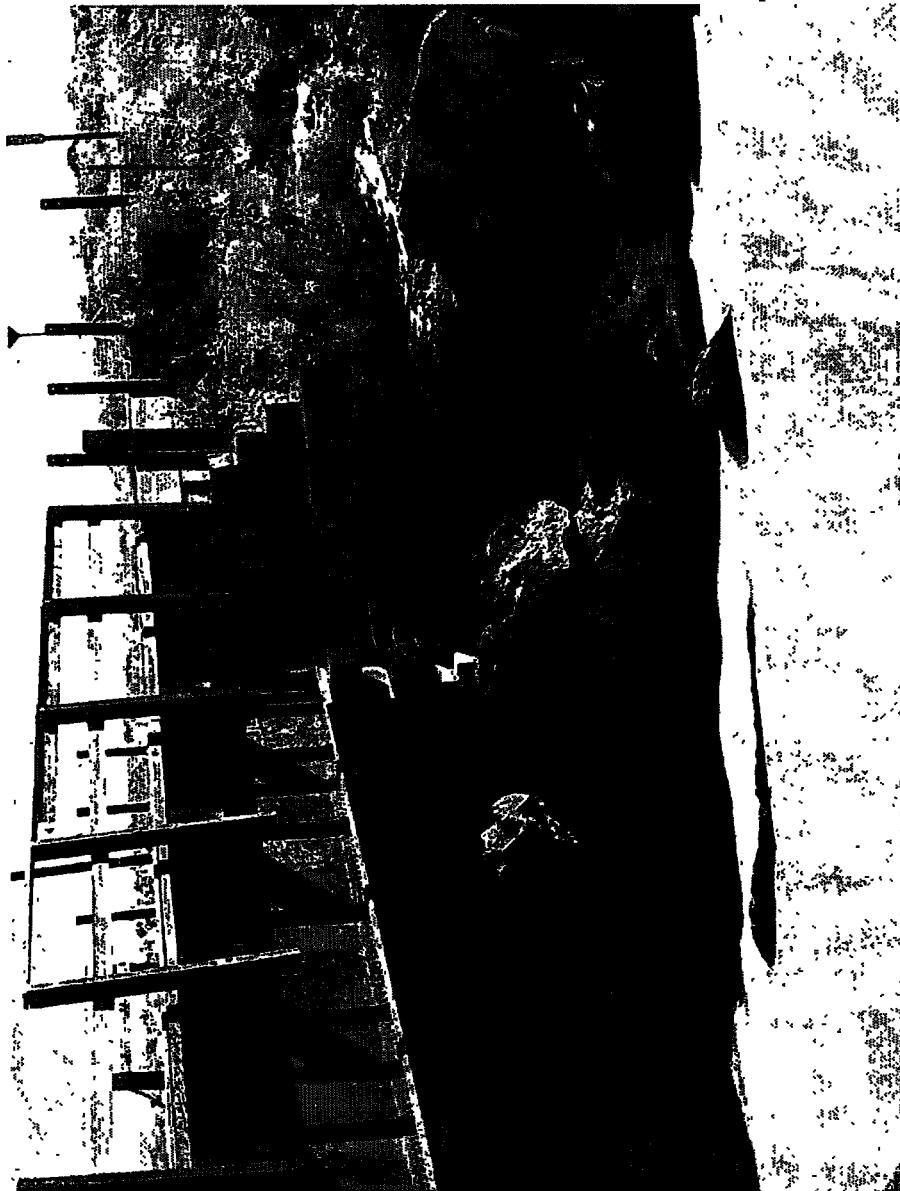
This photo shows a 3 foot times 16 inches times 8 inch thick concrete pad at the south base of the San Antonio Bridge. Creosote-treated soft wood material rests on concrete pad and also rests on bedrock, which possible was subjected to overbearing weight at one point in time .

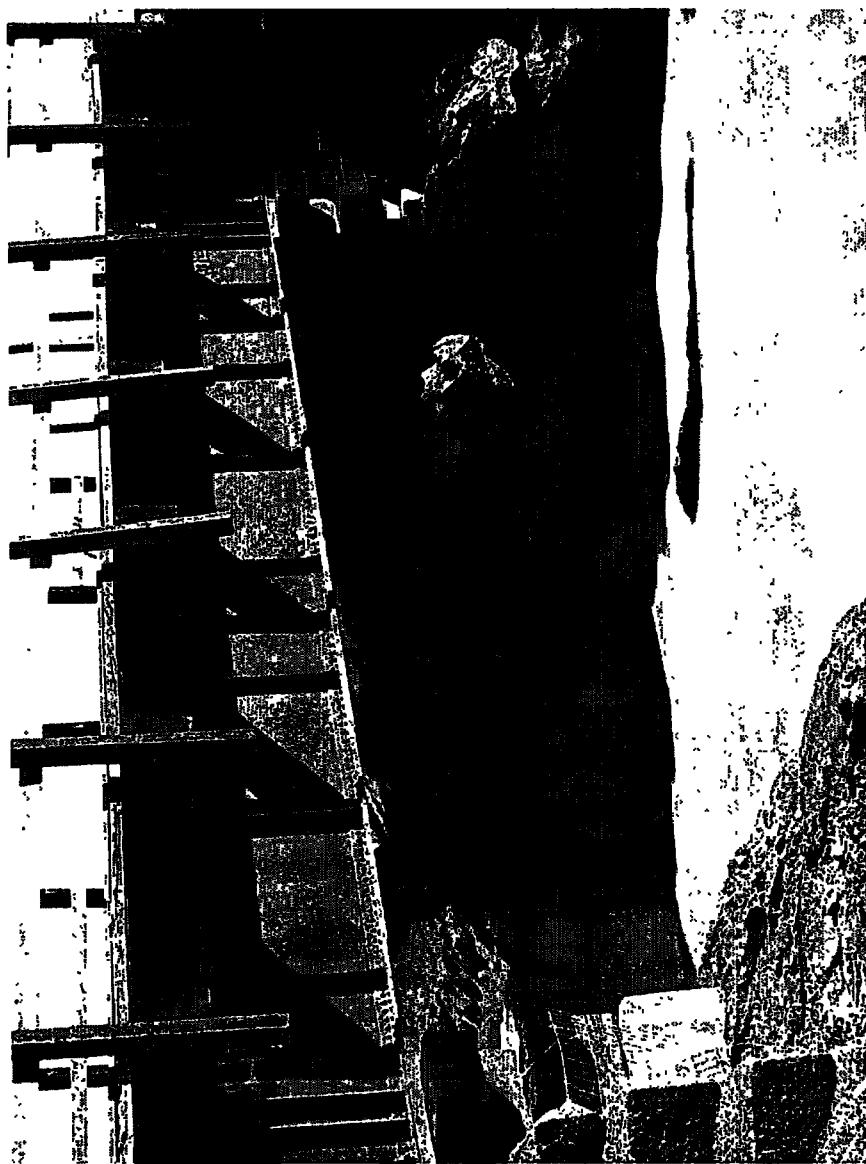
North and South perspective of the San Antonio River Bridge base, reflect the positioning of the 8 inch concrete pads in more detail. 8 inch x 8 inch soft wood rest on top of the concrete pads and wedges have been driven to apparently tighten the bond between the "J" beams and the soft wood material.

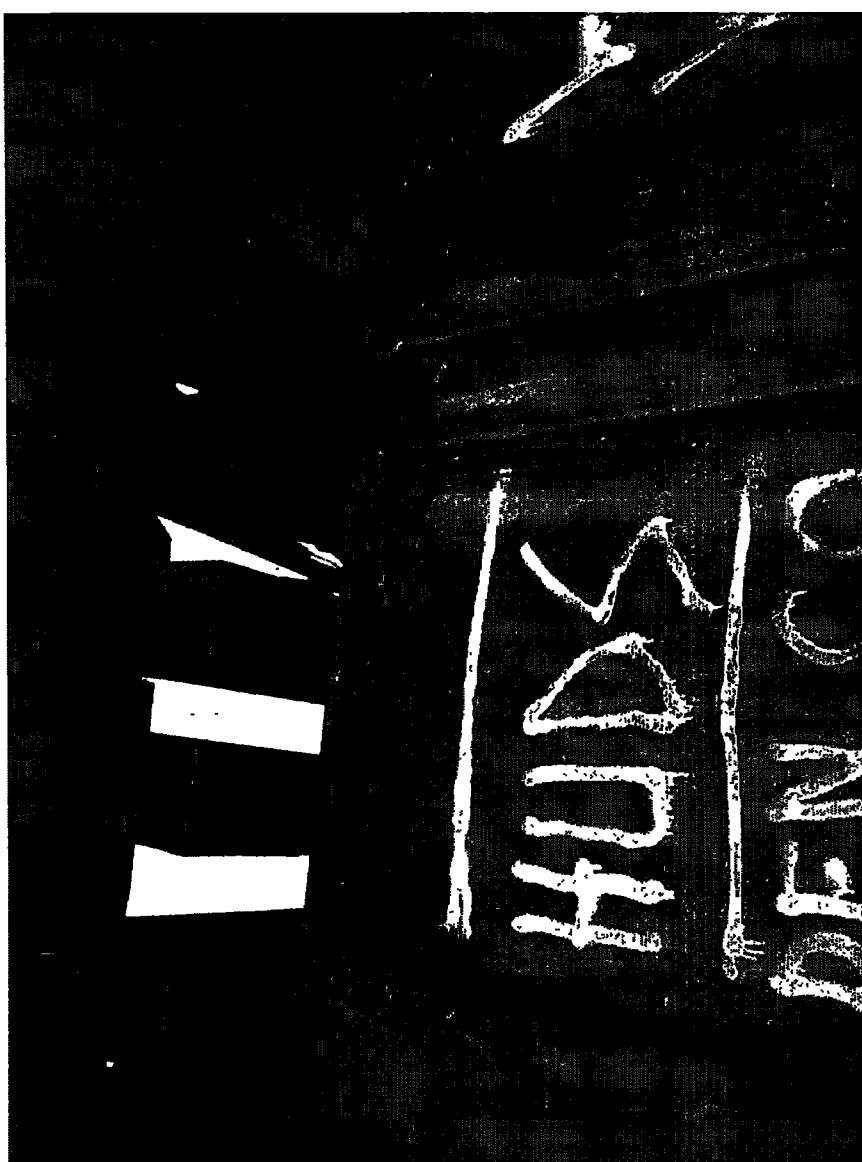
Bottom of the San Antonio river bridge indicates the support group resting on top of the "I" beams. Beams are spaced one foot apart and railroad ties are spaced 8 inches apart. Stress fractures are indicated in this photo. It is assumed that loading ability is substantially altered due to stress fractures in the soft wood, which is also Creosote. Railroad tie spacing allows for polluting the river.

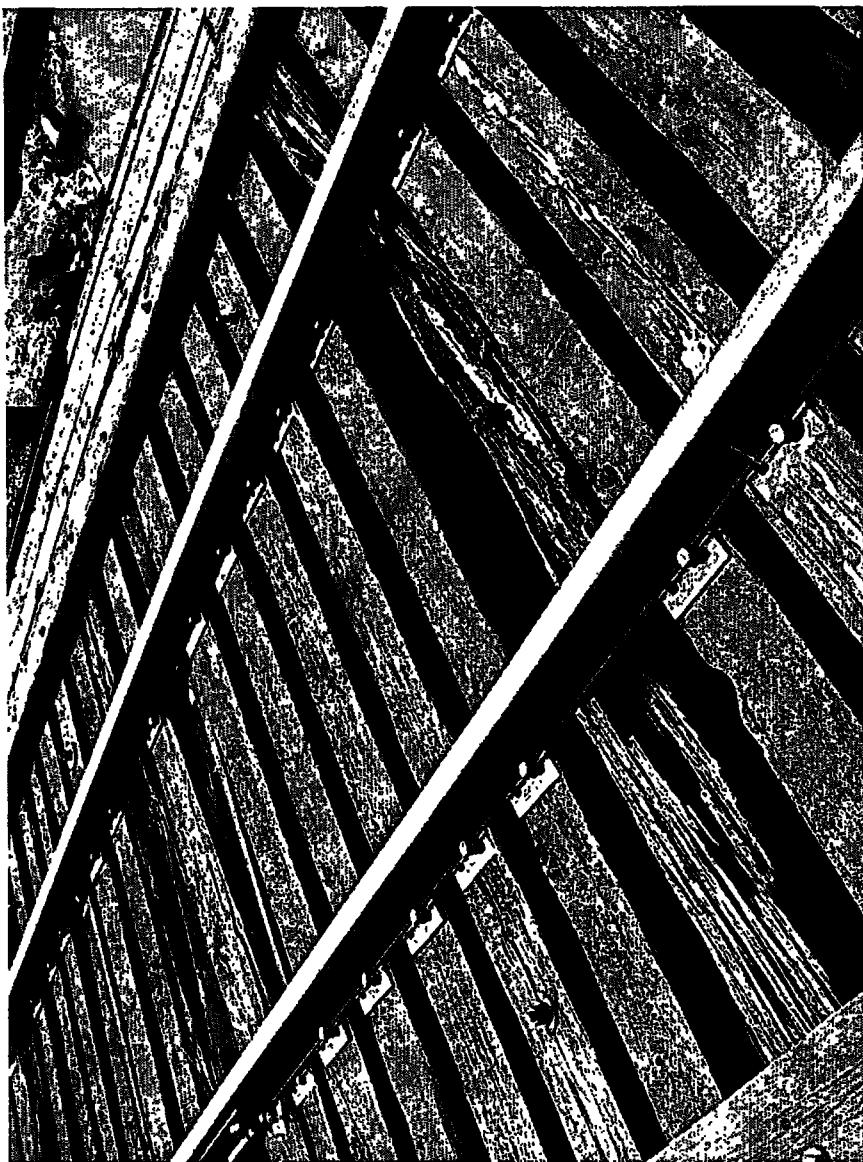
Top view of the San Antonio Bridge

This photo suggest that two spikes are allotted per each tie plate. Many circumstances indicate protruding spikes, misaligned tie plates and no indication that ties were pre-bored to receive single and/or not double spikes. Consequently several stress fractures are indicated in this photo—some to the extent that they currently serve no functional purpose.

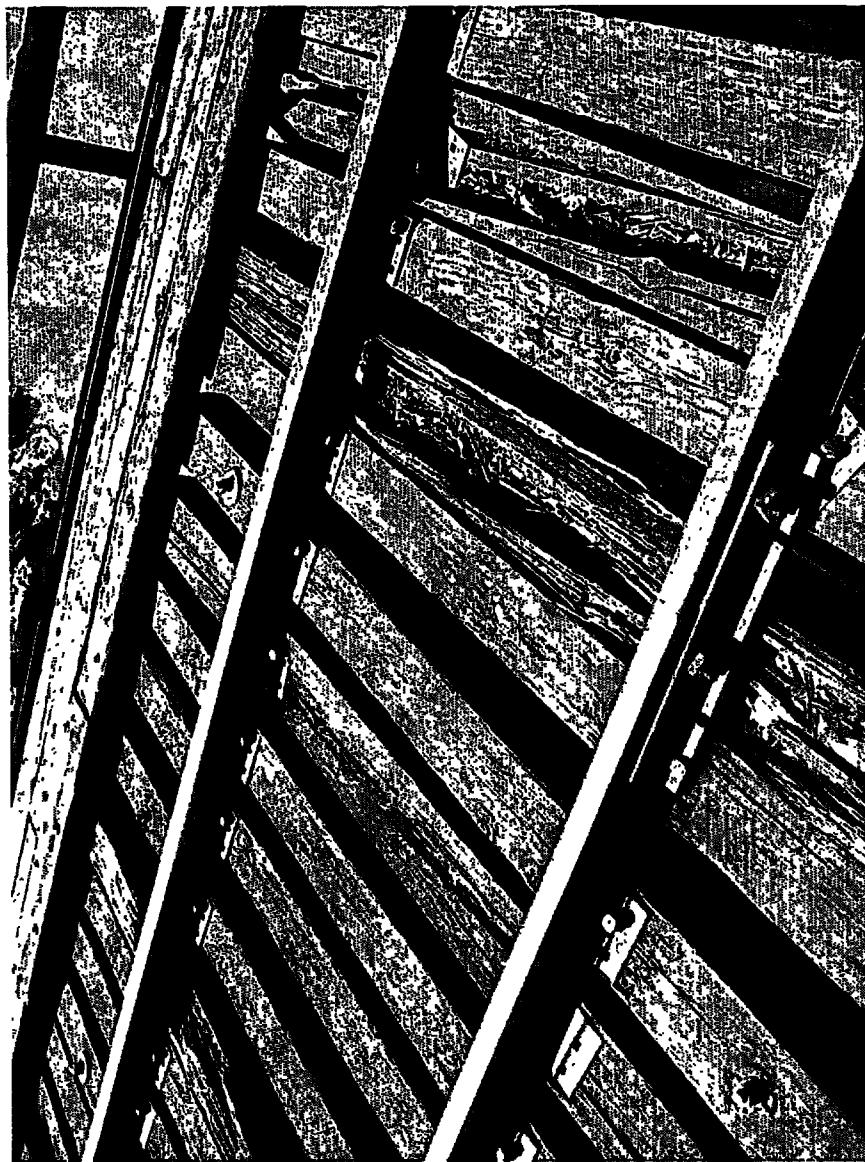
San Antonio Bridge, at the track top, reflects various railroad ties which obviously have to be replaced.

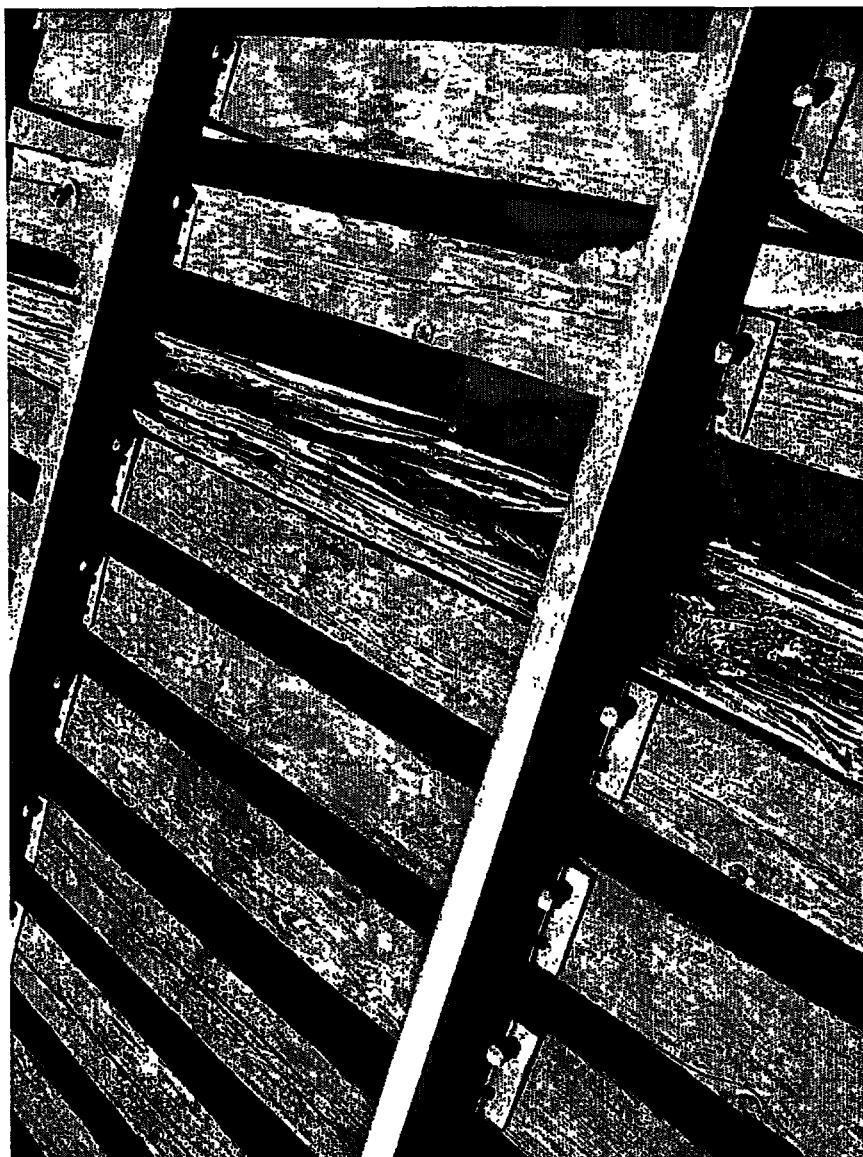
This photo of the top of the San Antonio Bridge shows at least one tie that obviously has to be replaced. The mere fact that it is misaligned, lacks spikes, lacks tie plate, and is not consistent with the given 8 inch spacing, may give a hint as to whether or not it should be replaced. Also, it should be noted that the San Antonio River is vulnerable to any aspect of the operation of the railroad, as static "green water" can be noted below.

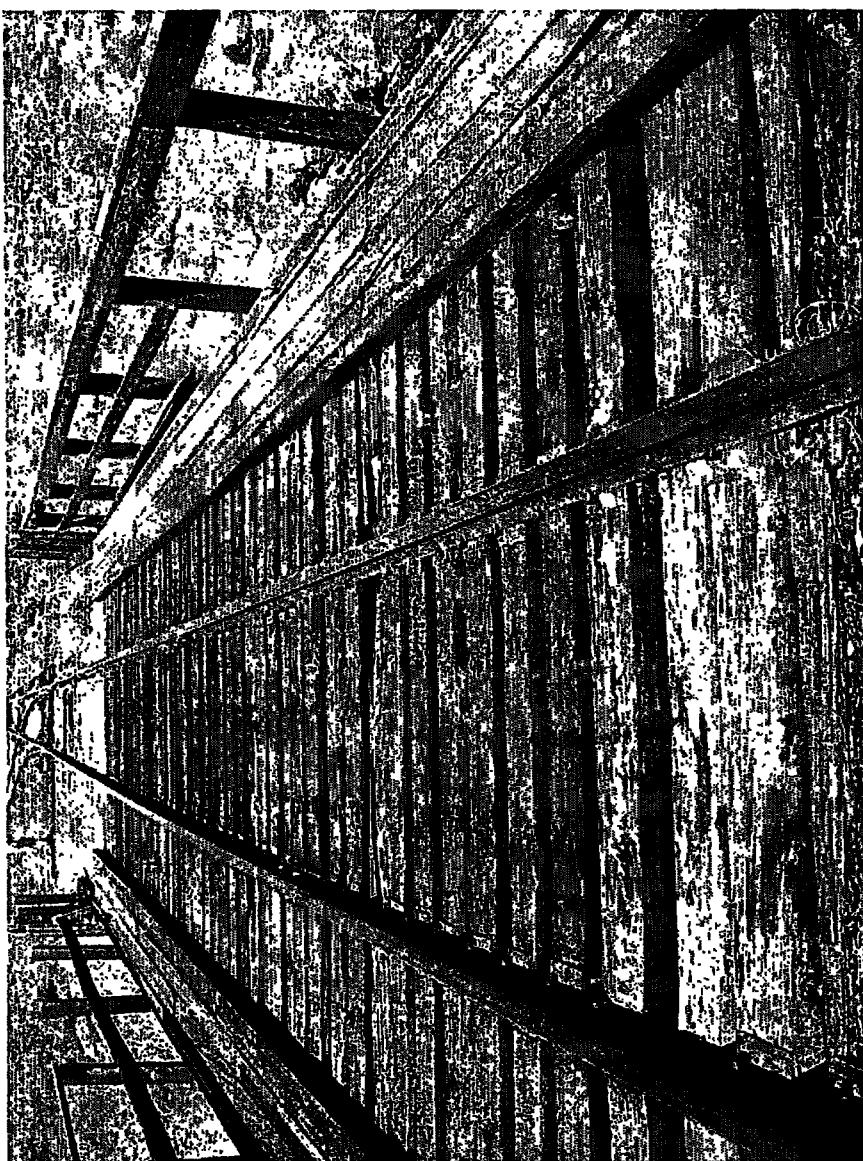
Top view of the San Antonio Bridge

Catwalks are indicated on either side of the rail head and are 3 feet wide by 54 linear feet long. While the catwalks may carry no functional value, they reflect the lax maintenance and the current condition of the bridge.

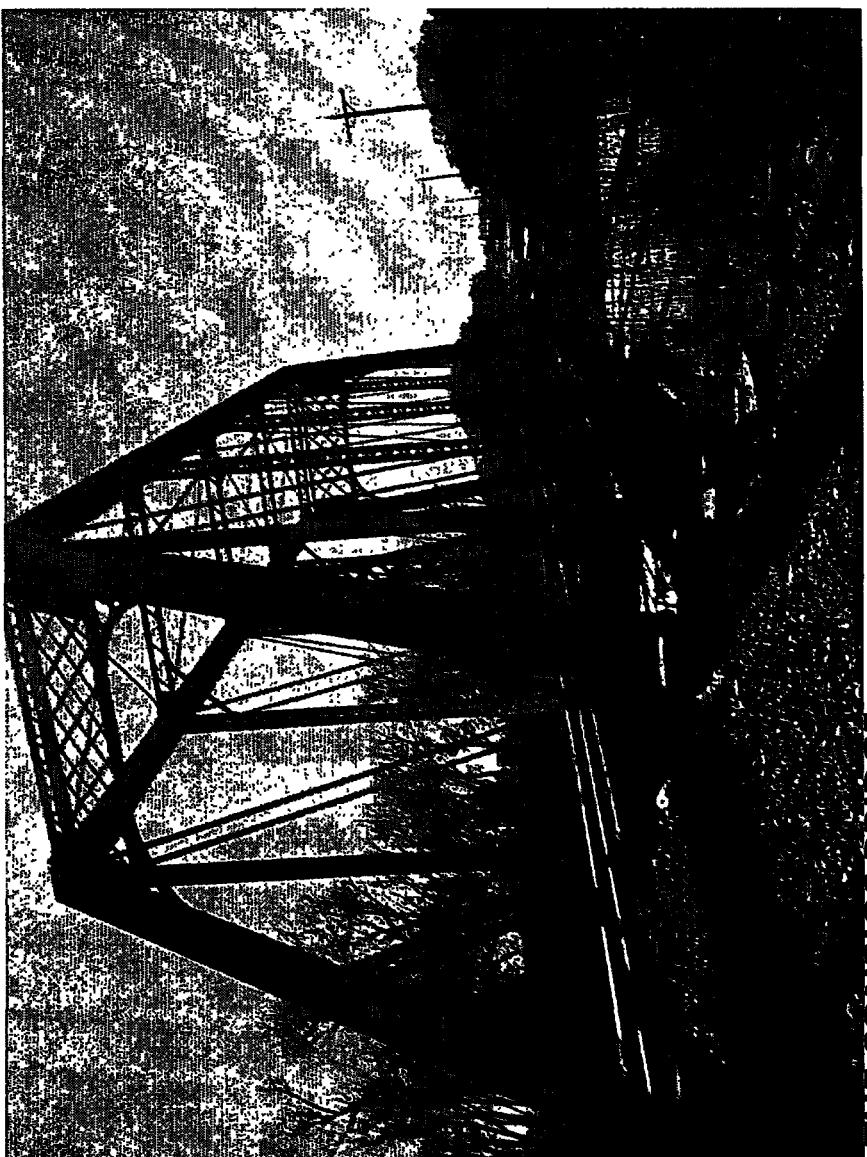
THE CONEJOS BRIDGE NO DATE OF CONSTRUCTION NO WEIGHT CAPACITY

The most telling feature in this photo is the lack of any literature to suggest what the loading capacity is on the Trussed RR Bridge situated at N 37 degrees 06' 05" W 105 degrees 00' 24". Elevation here is 7857 feet above sea level. The bridge is 10' wide at the top by approximately 60' long. A bridge of similar design approximately 8 miles East on COHWY 142 was discontinued by the State of Colorado back in the 70s because of some loading malfunctions. A significant event that currently occurs is the situation of the bottom cord running well over 130 feet on either side of the river resting on what could be Basalt or Granite. In either case, it appears that the weight of the bridge alone plus that of superimposed loads could possibly alter the structural integrity of the bearing soil and loading points. Oxidation of metal appears to be in abundance, and for the sake of argument does not appear to be primed an/or painted for a substantial period of time.. Various railroad ties are in the state of requiring at least some maintenance or repair.

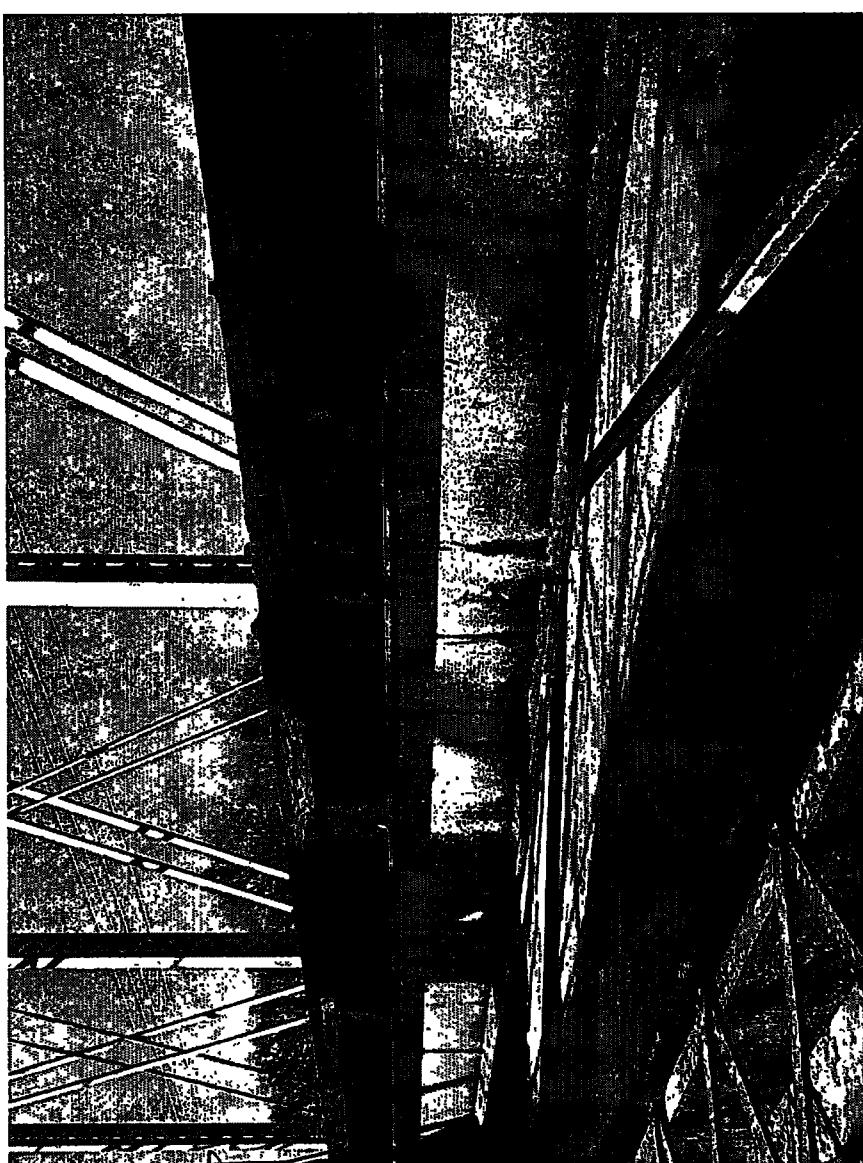
This photo clearly illustrates discoloration at all steel components. It is safe to assume that the structure has not recently been sanded, primed, and painted for a substantial period of time.

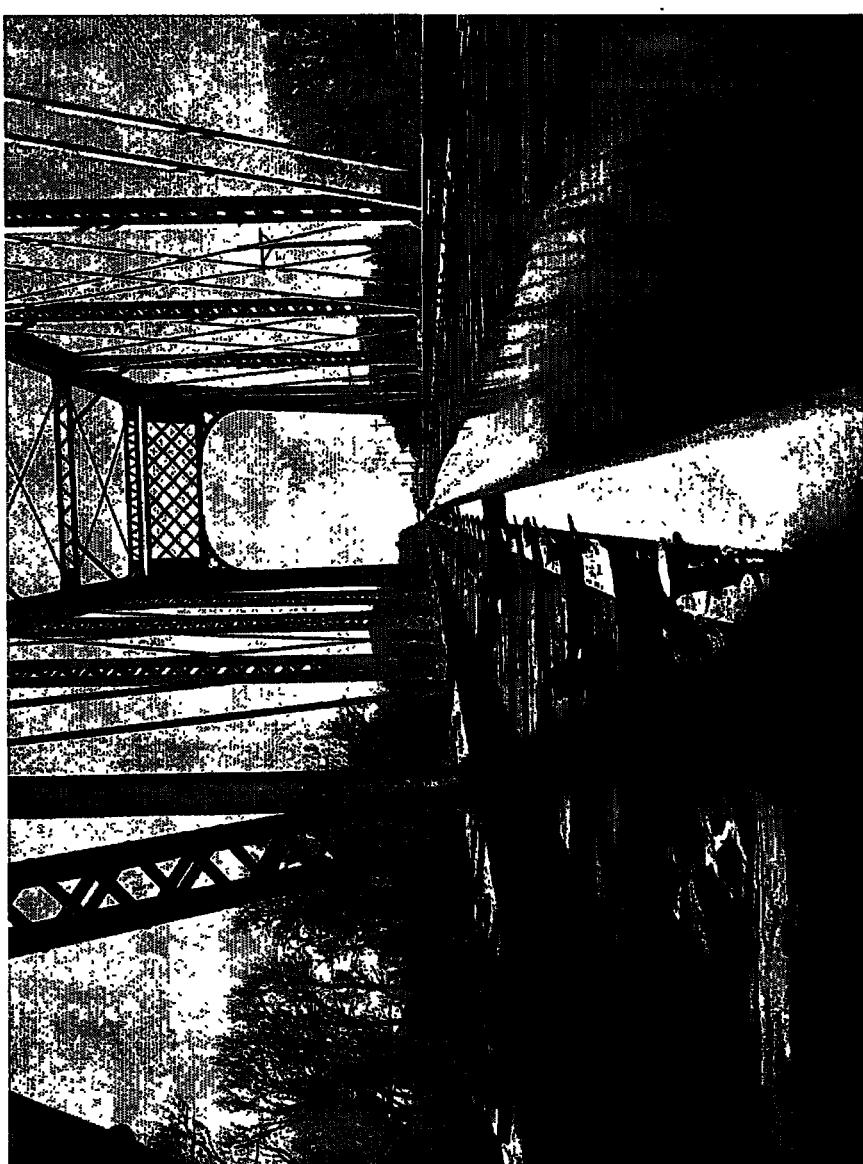
Several railroad spikes are disassociated from ties and the plates, as can be seen in this photo.

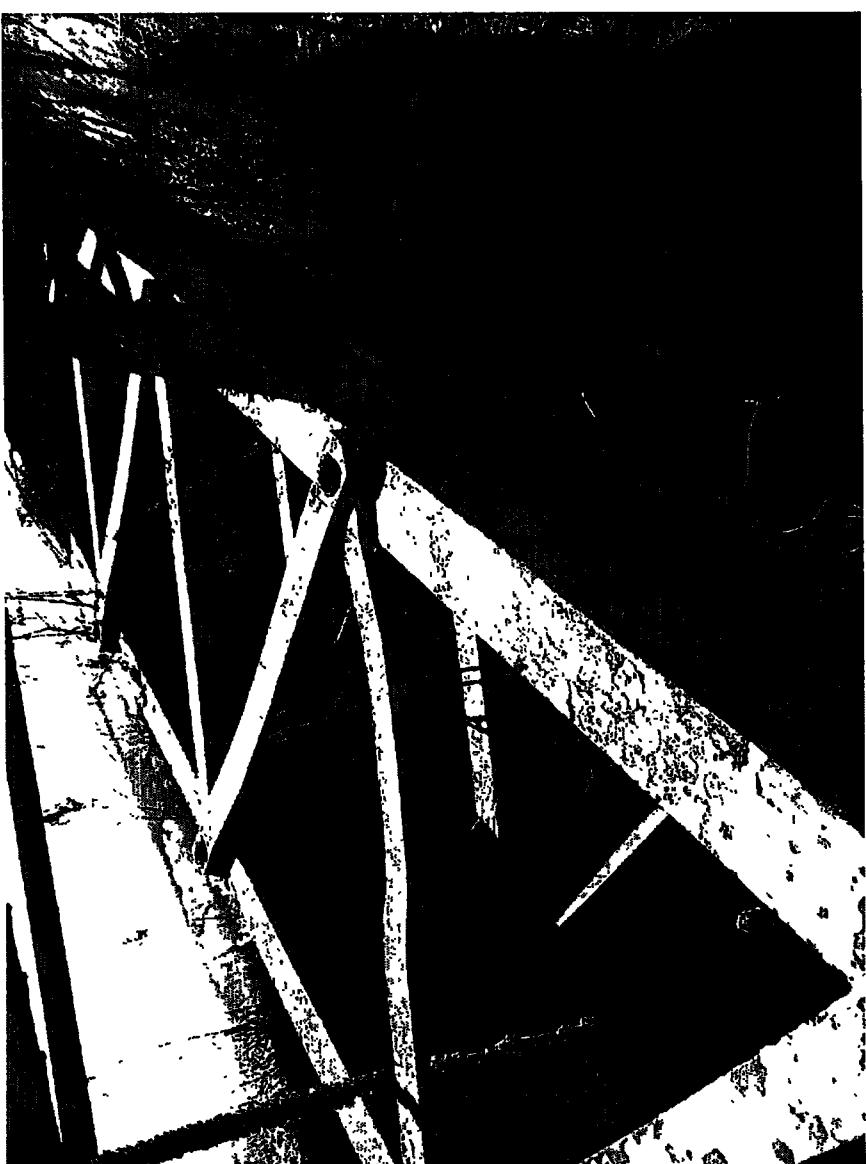
This photo notes web members that are bent revealing possible racking stress points. Note that there has been very little or no maintenance at all in terms of sanding, priming, and painting.

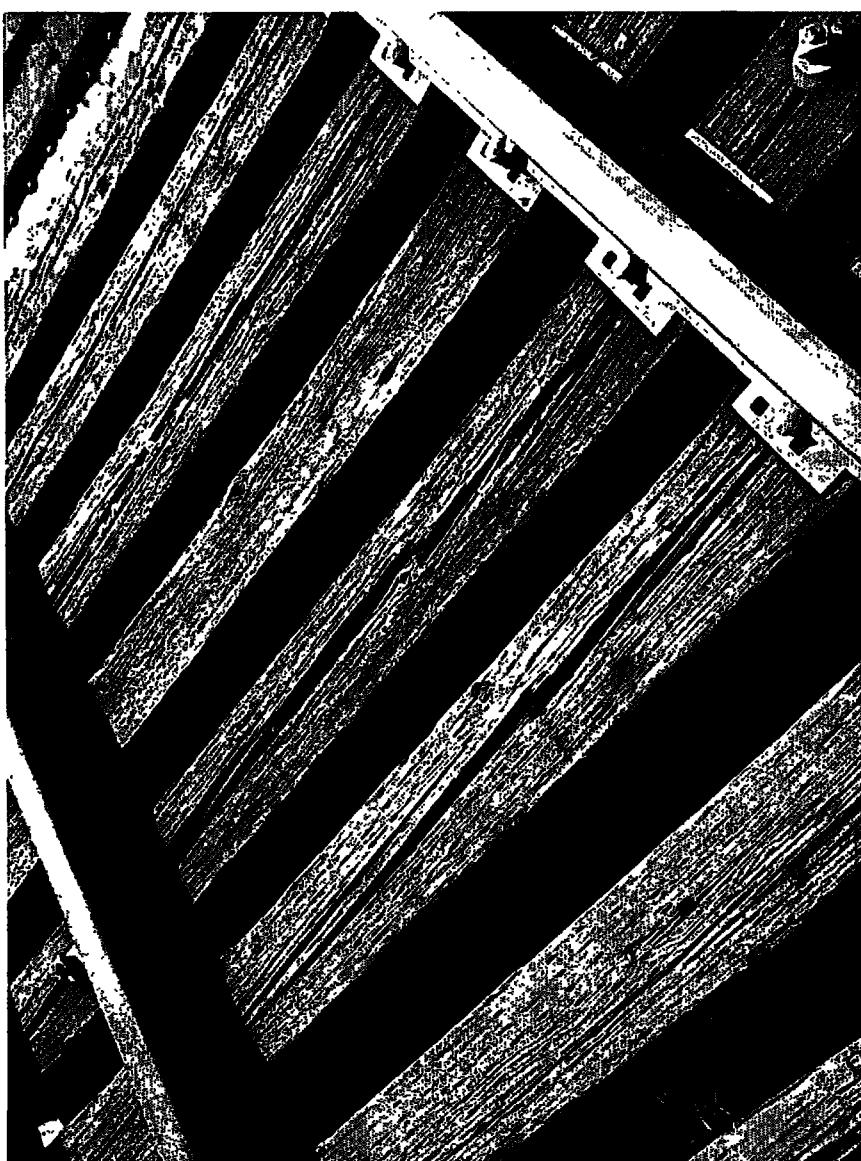
Top of RR Trussed Bridge over the Conejos River reflects various rail ties which could stand to be replaced. Note that one spike on each tie plate anchors the rail to the RR tie. Many instances suggest that the spikes may not have been slightly under-bored in order to prevent the tracks shown in the photo.

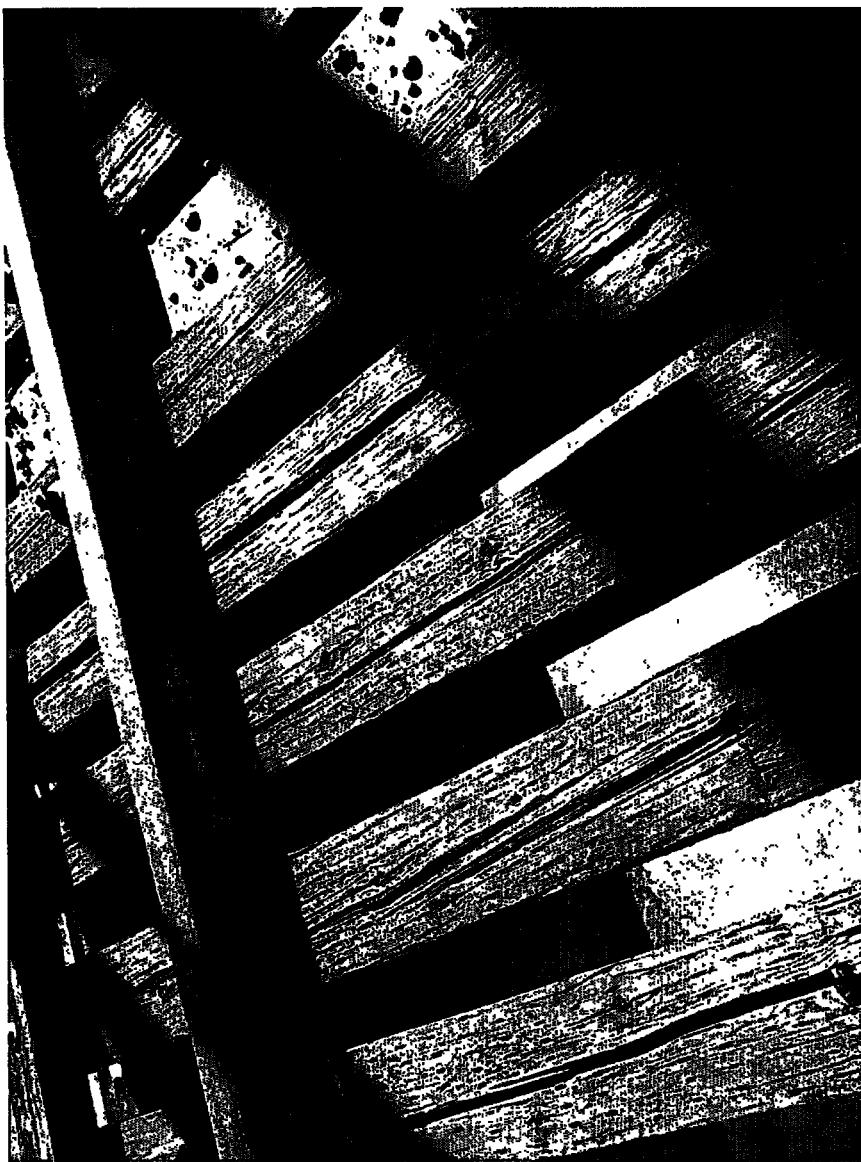
A series of railroad ties indicate approximately 8" spacing, thereby exposing the Conejos River to any material which may 'drop through'.

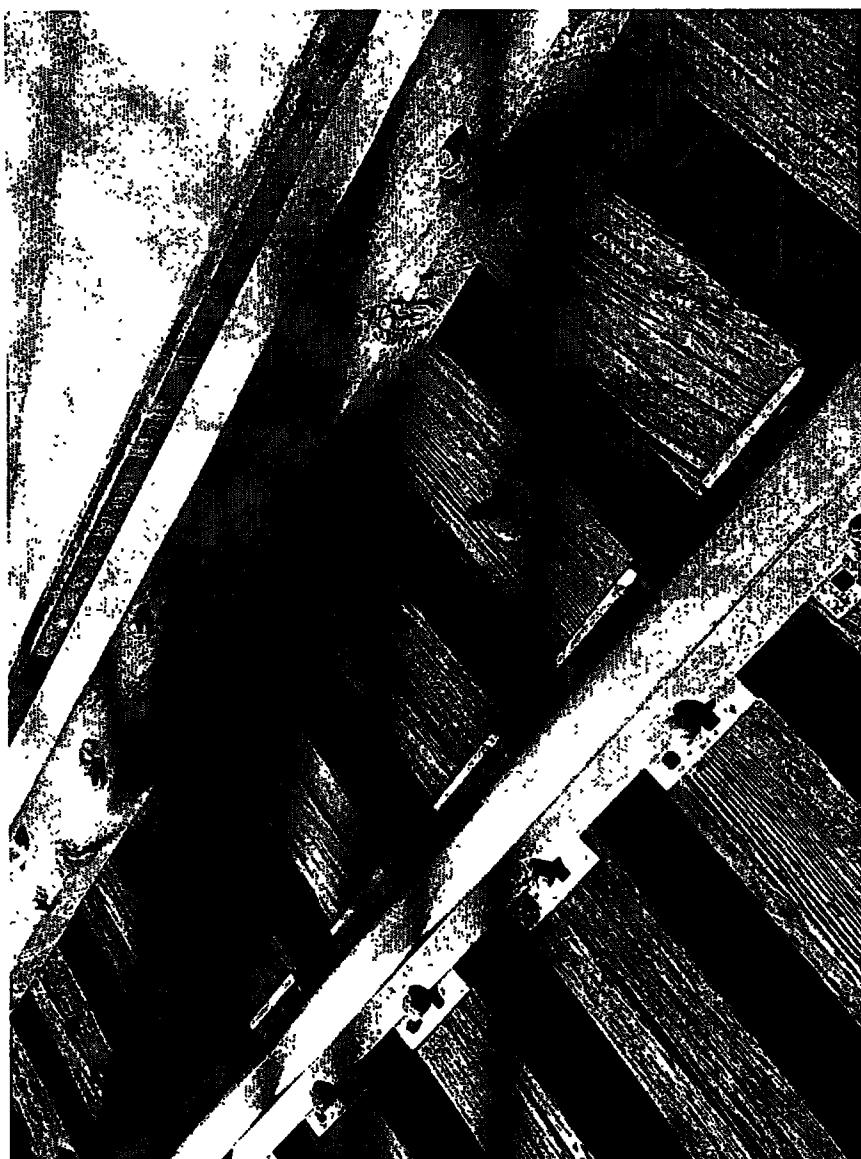
Here a 'catwalk' adjacent to a ledger (the outer perimeter of the bridge edges, which run perpendicular to the railroad ties) show bolts, which serve as structural fasteners, and possible create an adverse situation. Future maintenance would require the disassociation of fasteners from timber and railroad tie members, thereby making for a tedious process. This photo suggests some structural defects, most notably cracks in the ties.

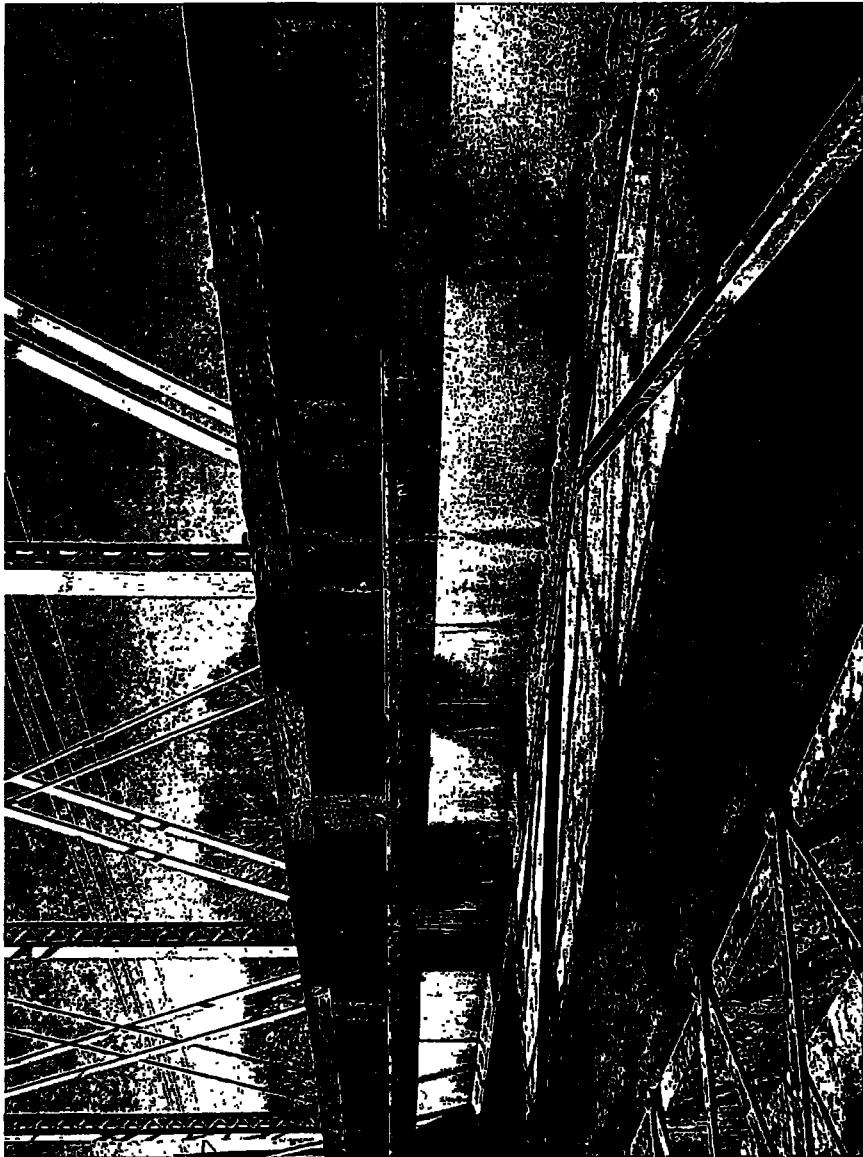
This photo clearly illustrates discoloration at all steel components. It is safe to assume that the structure has not recently been sanded, primed, and painted for a substantial period of time.

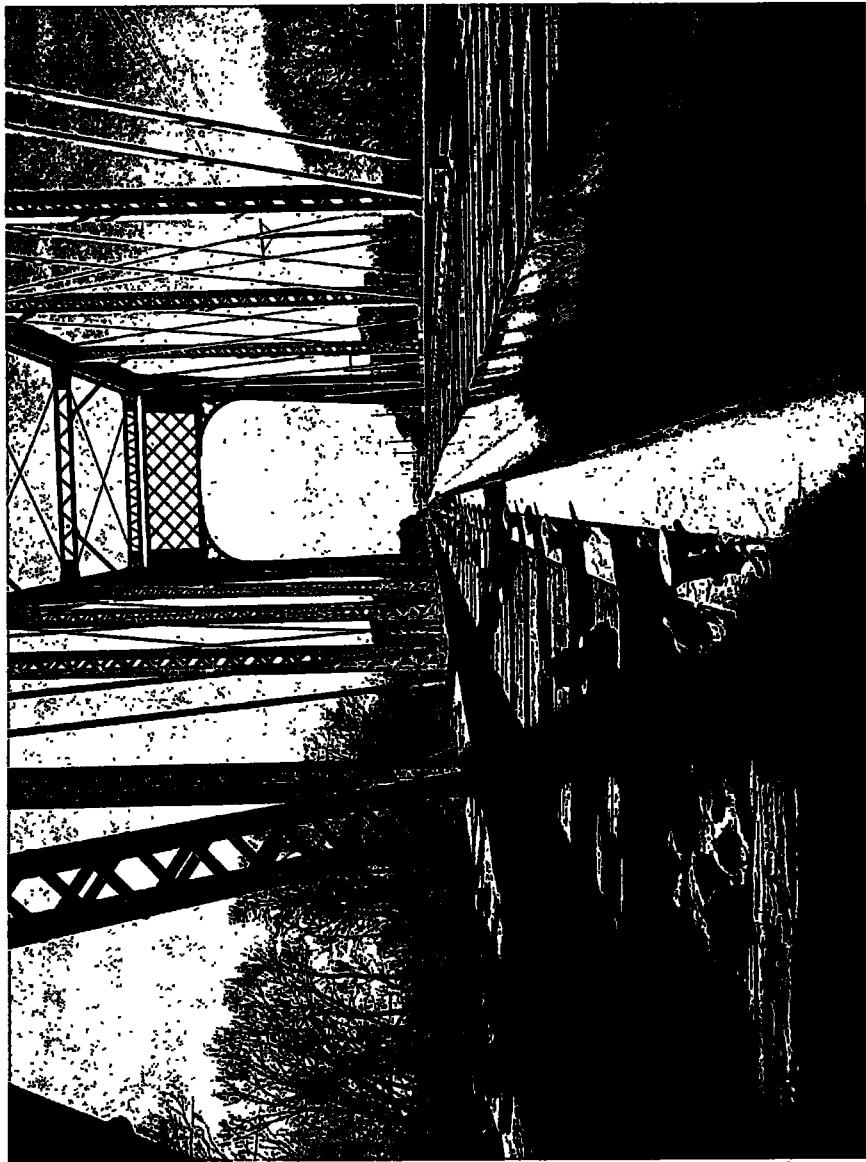
Several railroad spikes are disassociated from ties and the plates, as can be seen in this photo.

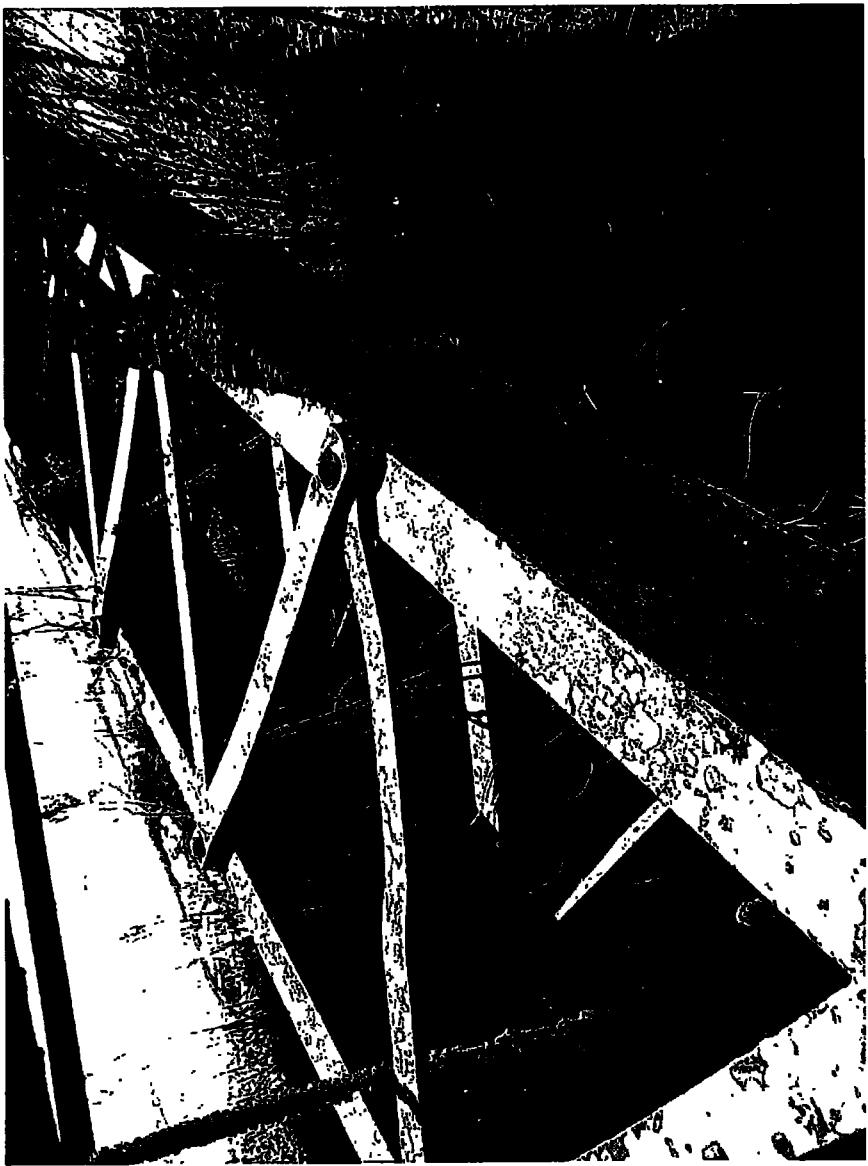
This photo notes web members that are bent revealing possible racking stress points. Note that there has been very little or no maintenance at all in terms of sanding, priming, and painting.

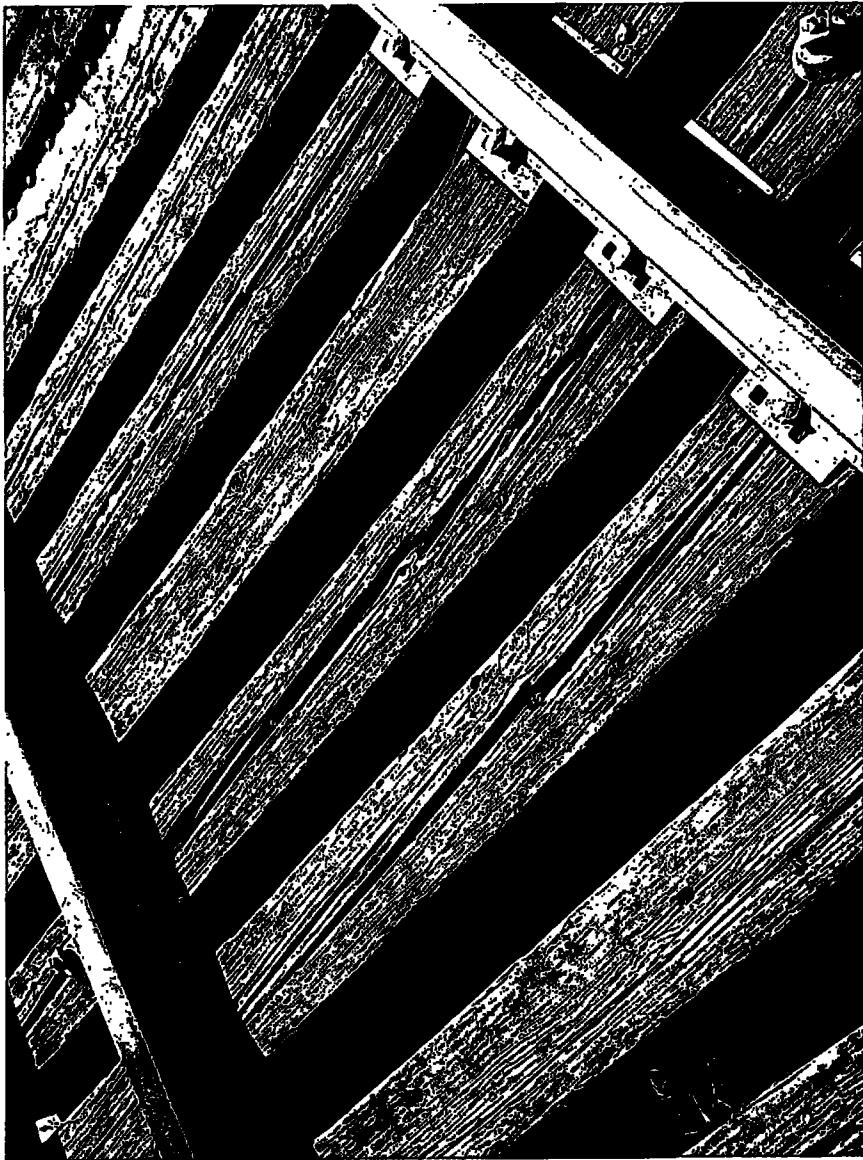
Top of RR Trussed Bridge over the Conejos River reflects various rail ties which could stand to be replaced. Note that one spike on each tie plate anchors the rail to the RR tie. Many instances suggest that the spikes may not have been slightly under-bored in order to prevent the tracks shown in the photo.

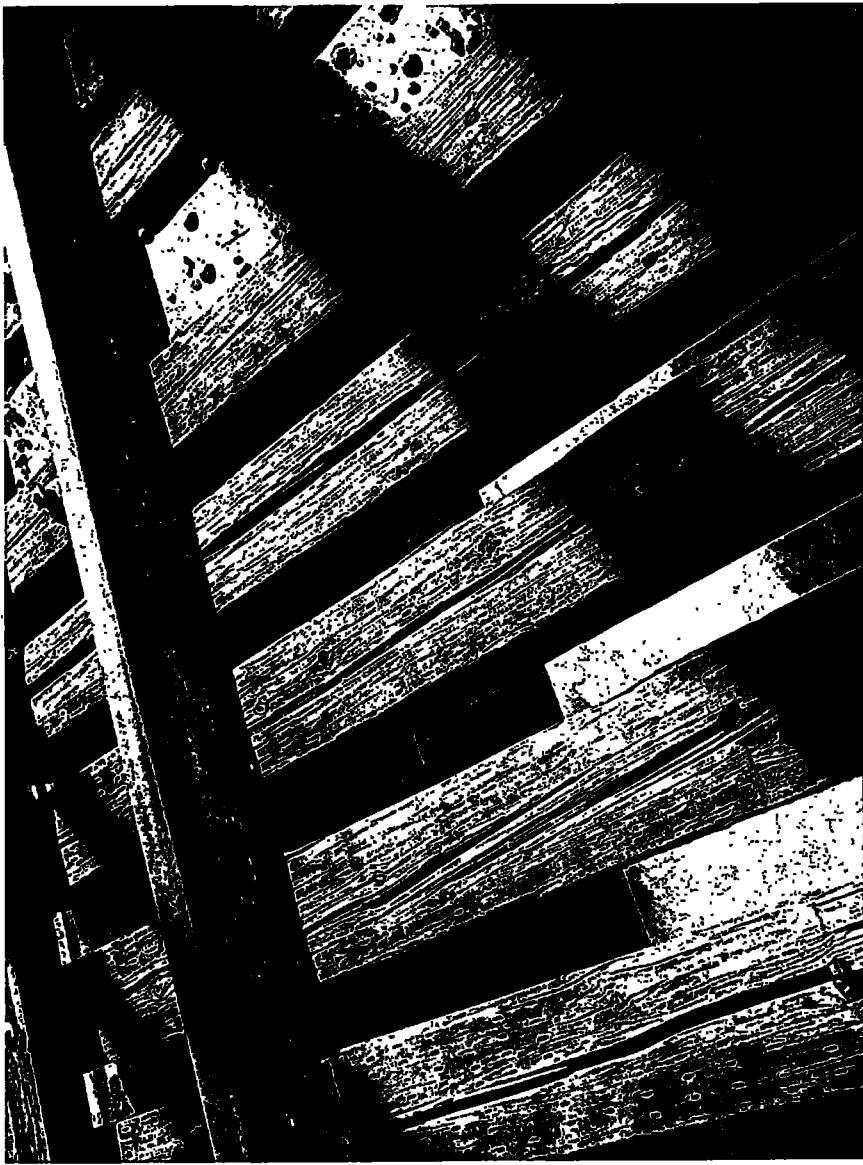
A series of railroad ties indicate approximately 8" spacing, thereby exposing the Conejos River to any material which may 'drop through'.

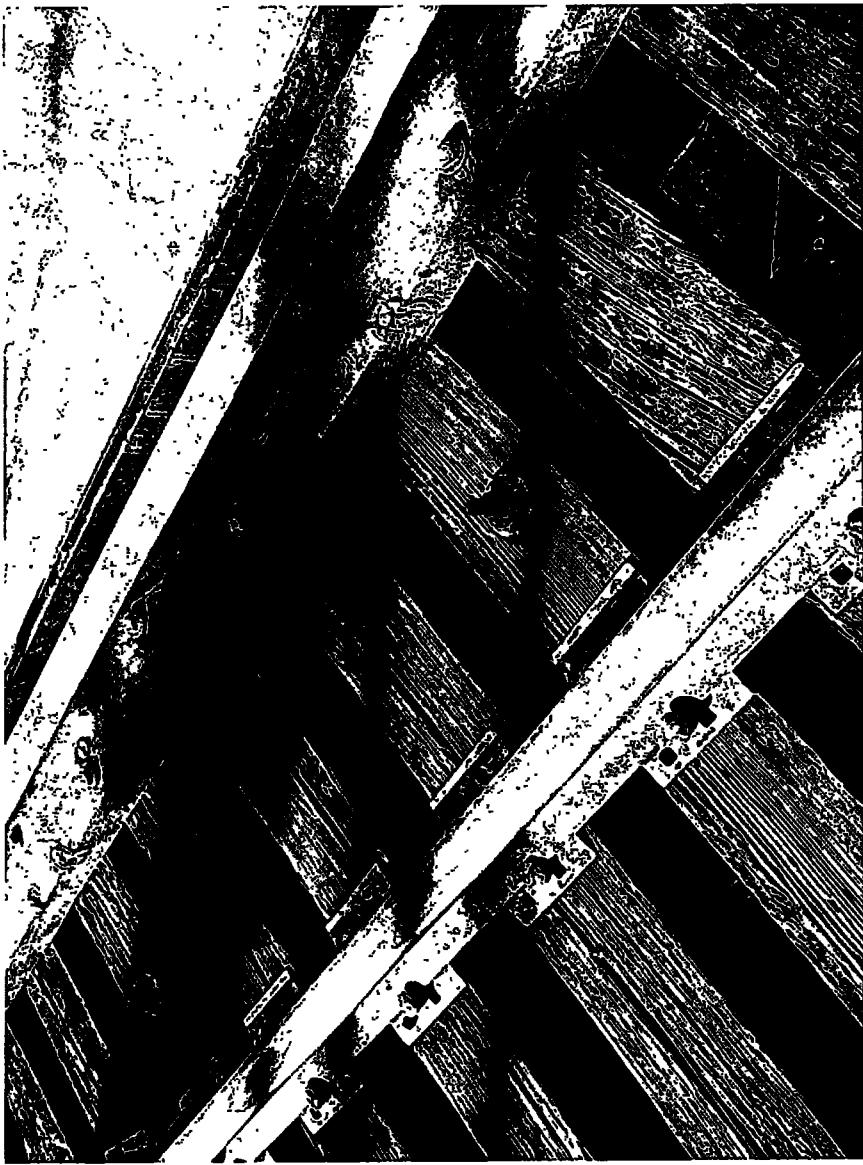
Here a 'catwalk' adjacent to a ledger (the outer perimeter of the bridge edges, which run perpendicular to the railroad ties) show bolts, which serve as structural fasteners, and possible create an adverse situation. Future maintenance would require the disassociation of fasteners from timber and railroad tie members, thereby making for a tedious process. This photo suggests some structural defects, most notably cracks in the ties.
